Development Testing and Subsequent Failure Investigation of a Spring Strut Mechanism

Abstract

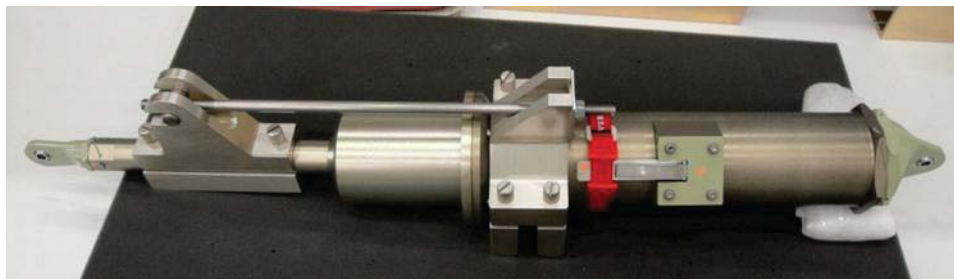
Figure 3. CM-SM Umbilical Spring Strut with Retention Tool

After compressing the strut to the stowed flight length, a retention tool (shown in Figure 3) was applied to sustain the compressed state of the strut. The retention tool interfaces with two thru tooling holes located in the secondary piston and the body of the actuator housing. The tool was applied after initial assembly, after pre- and post-random vibration performance testing, and during reconfiguration between random vibration test axes.

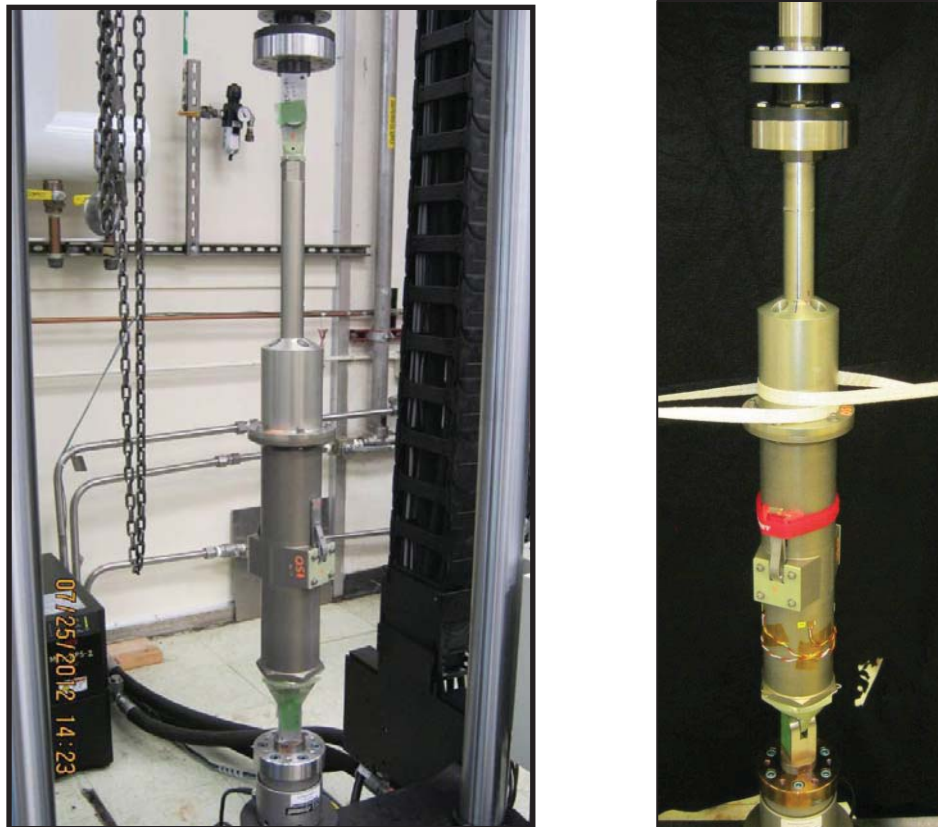
Figure 7. Test Setup for Performance Testing (Pre-Vibe [left] and Post-Vibe [right])

In the performance test, the development spring strut was exercised at a slow rate from the flight configuration (stowed) to the extended position (Figure 7) to measure the load versus displacement characteristics and observe the function of the anti-back-travel latches. In the wear-in test, the strut was exercised 15 times at nominal deployment speeds (394 mm/s (15.5 in/s)). During the test, the strut was stroked from the flight length to the extended position to reach steady state performance and to observe potential wear or performance degradation. After wear-in, the strut was stored at the flight configuration with the retention tool applied and shipped to the random vibration testing facility.

After failure during the random vibration testing, the strut was returned to the performance testing facility with a truncated secondary piston to remove the failed portion of the strut. Using a cupping interface, post-vibe performance deployment tests were performed with the strut assembled in the load frame. The post-vibration performance test served primarily to assess whether there were any large excursions from the nominal force-deflection curve. These excursions could be indicative of significant damage to the spring strut sliding surface. The post-vibration performance test satisfied the nominal expected end of travel force of $165 \text{ N} \pm 27 \text{ N}$ ($37 \pm 6 \text{ lb}_f$) and resulted in nominal engagement of the anti-back travel latches. Force versus displacement within the expected tolerance yielded acceptable force margin based on the next high assembly assumptions and calculations. A comparison of the pre- and post-random vibration performance test is shown in Figures 8.

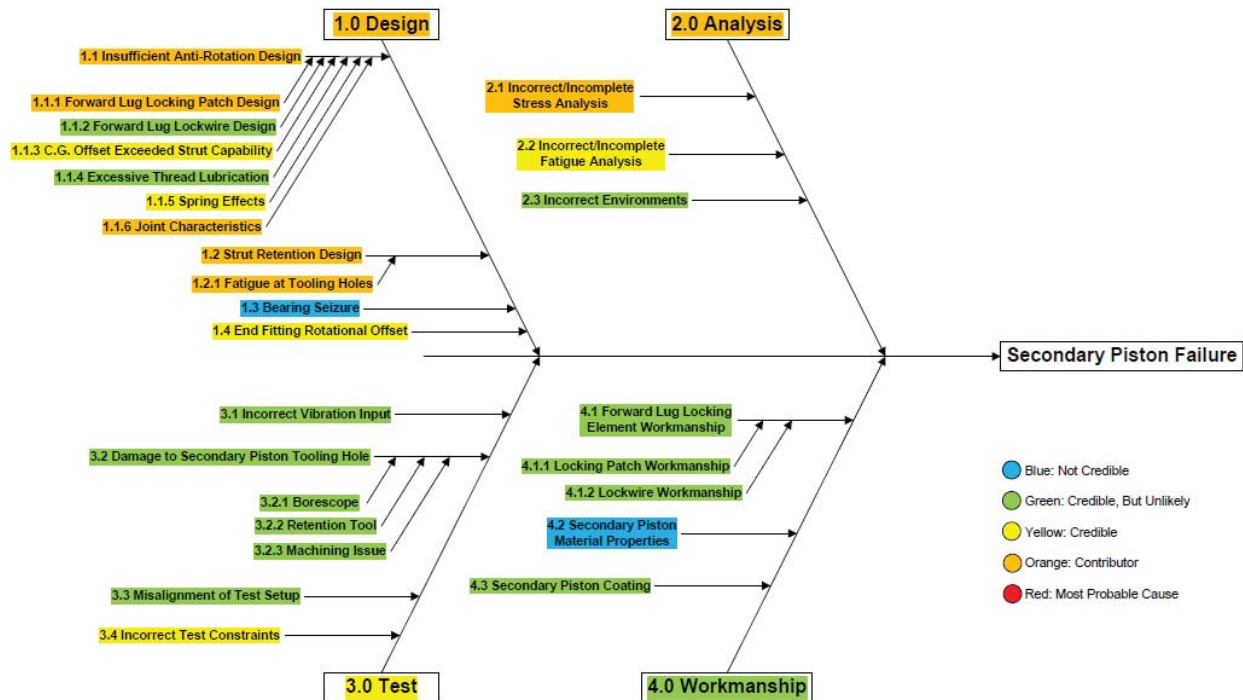
Figure 9. Fishbone Diagram

Immediately following the strut failure, the joint NESC and LM team generated a fishbone diagram. Individual elements were classified as aspects of design, analysis, test, and/or workmanship. Related and supporting evidence was gathered to disposition those elements as either most probable cause, contributor, credible, credible but unlikely, or non-credible. The NESC/LM joint investigation occurred over a month whereupon, due to MPCV Program schedule pressure, LM chose to implement corrective actions addressing identified proximate causes and assumed ownership of the CM-SM umbilical spring strut development test program. The NESC team continued the investigation in an effort to identify root cause and the most probable failure scenario. Supporting analyses were completed, photographic evidence was reviewed, and inspections were conducted to provide rationale for fishbone element classifications shown in Figure 9. Detailed information regarding the root cause investigation, including classification definition, can be found in the full NESC assessment report [1].
